STS-105/7A.1 FRR

**EVA Project Office
Johnson Space Center**

**Maria Tullar
August 1, 2001**

7A.1 EVA Mission Overview

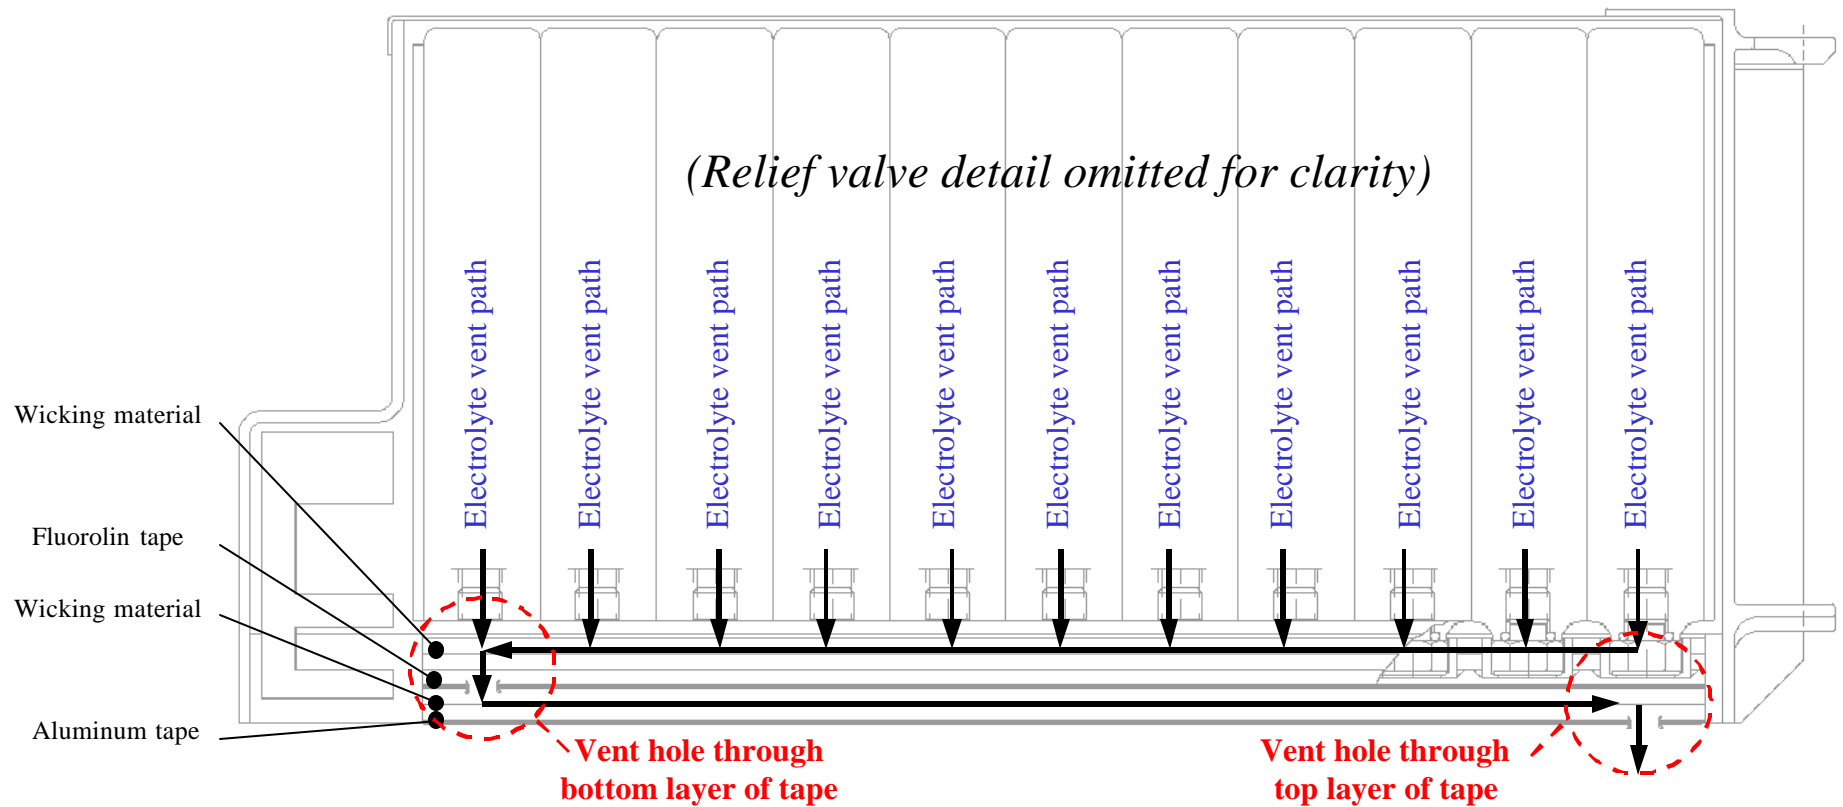
Increased Capacity Battery (ICB) Configuration

- During the first pre-EVA checkout on STS-104, the Increased Capacity Battery (ICB) S/N 2017 installed in EMU #3 was found to have leaked potassium hydroxide (KOH) outside the containment packaging of the battery

- The leakage deposited KOH on the Contamination Control Cartridge (CCC), the water tank structure, and other locations on the Primary Life Support Subsystem (PLSS)

- All five of the ICB's flown on 7A were formed/activated at the same time and with similar procedural deviations as S/N 2017. S/N 2017 was the only battery to be stowed and launched in an inverted position.

- Final root cause determination requires return and examination of S/N 2017. Evaluation ECD is August 3, 2001.
- All possible causes have been identified and screened for on S/Ns 2012 and 2014
 - Excess electrolyte during fill/formation process
 - Failed ICB relief valve(s)
 - Cracked cell
 - Inadequate wicking orientation/configuration
- Most probable cause of these is the deviation from nominal processing procedures and incorrect wicking configuration, both exacerbated by being stowed/launched inverted.

- ICB S/N's 2012 and 2014 have been successfully screened for all above causes and will not be stowed inverted
 - 7A.1 ICB's S/N 2012 and 2014 have been successfully screened for electrolyte leakage (inspection of wicking material revealed negligible KOH residue, wicking was changed out, and inverted orientation resulted in no leakage)
 - Additional layer of wicking material (allowed per B/P) was be added to ICB's S/N

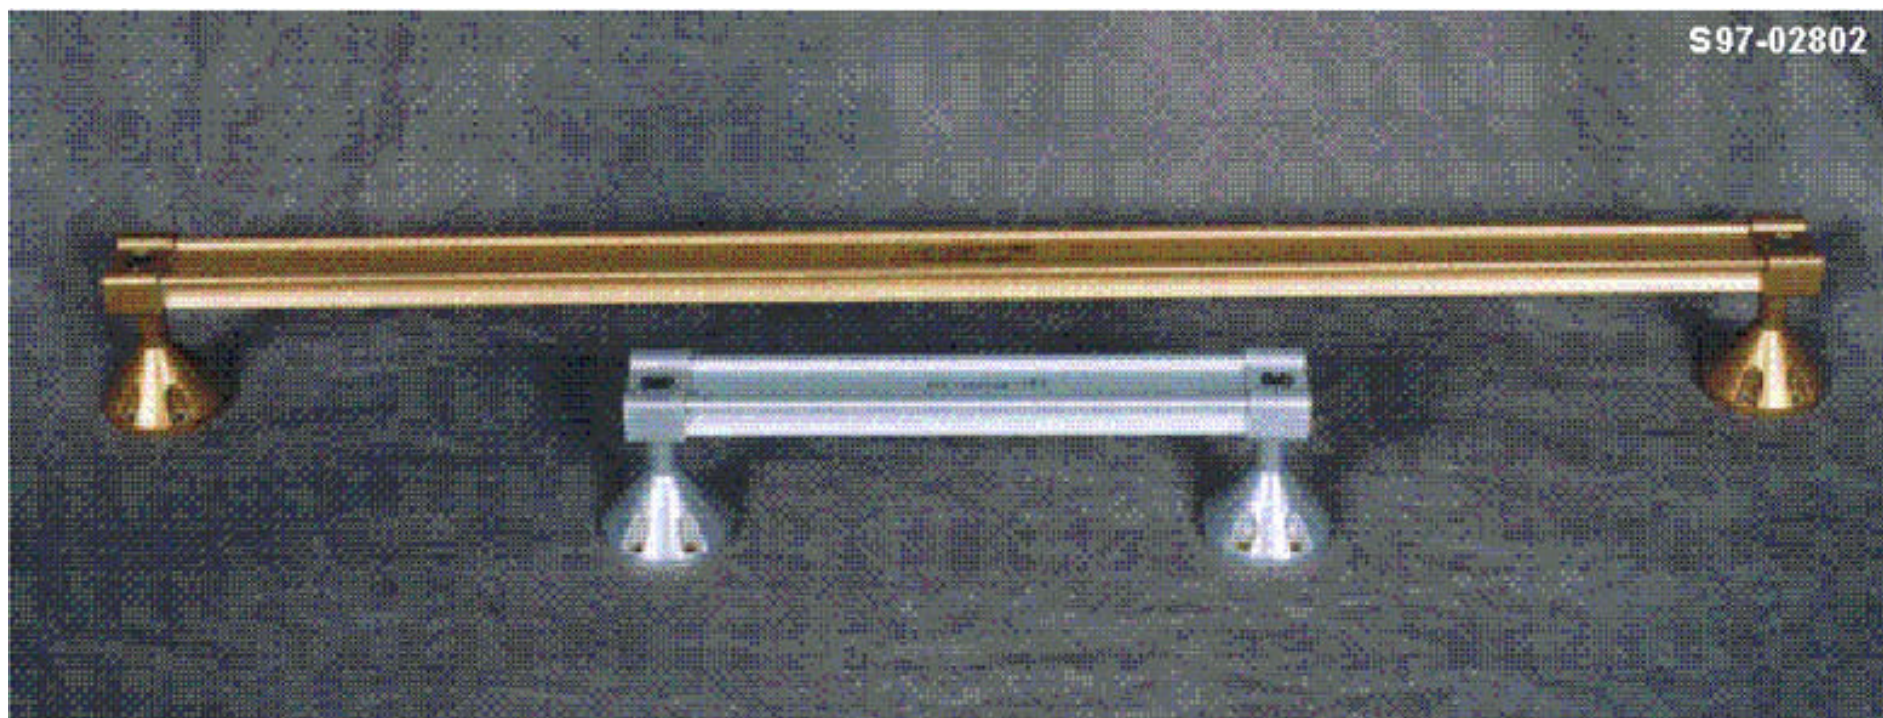
Corrosion in Top Mounted Handrail Brackets

- Aluminum oxide was discovered within the through hole of several brackets of gold anodized top mounted handrails during a PDA.
- The stem of a bracket was cut lengthwise and the aluminum oxide was removed to reveal a severe pitting of the base material.
- From these findings the Engineering Directorate's, Structures and Mechanics Division's, Test Branch, has recommended that handrails with similar corrosion not be used since fracture analysis has yet to be completed on the corroded brackets.
- Other EVA Handrails assembled with this type of bracket are also under suspicion.
 - Custom EVA Handrails
 - Clear anodized top mounted handrails

- Investigations indicate that the corrosion is caused by the chemicals used during the anodizing process not being properly cleaned from the handrail bracket.

- An Interim FIAR closure for STS-105/7A.1 has been approved since the crew will not be safety tethering to Top Mounted Handrails during scheduled EVA Tasks.
- This anomaly is not a constraint to STS-105/7A.1.

- Determine if corrosion is only occurring within one lot of handrails brackets.
 - Initial inspection of 130 brackets representing 16 different lots supports that the discrepancy is contained within one lot.
- Determine the current locations of all the brackets from the known discrepant lot in order to replace affected handrails.
 - STS-105/7A.1 has not received brackets from know discrepant lot.
 - STS-108/UF-1 is the first flight which has received brackets from discrepant lot.
- Inspect the remaining brackets from the known discrepant lot to discover the worst corroded bracket. Potential to perform testing to determine if the handrail still meets safety tethering specifications is still under consideration.

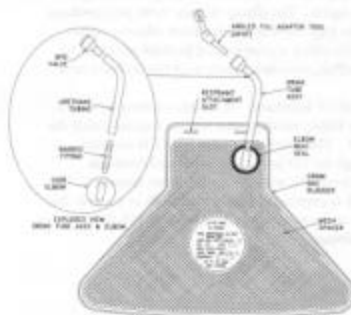
FIGURE E.1 DISPOSABLE IN-SUIT DRINK BAG (DIDB) COMPONENTS

- During STS-100 a crewmember had a burning sensation in both eyes during EVA
 - Previous eye irritation scenarios had occurred during the repress phase of EVA, and were attributed to exposure of eyes to anti-fog solution (soap)

- Most likely cause determined to be irritant (most likely anti-fog solution) being transported into crewmembers eyes by leaking disposable in-suit drink bag (DIDB)
 - For STS-105/7A.1, DIDB is being replaced with a previous configuration in-suit drink bag (IDB) to eliminate potential leaking bite valve and thus control one known transport mechanism. IDB valve is much less susceptible to leakage
 - For ISS-3/Stage 7A.1, the risk of DIDB leakage as a transport has been accepted for any contingency EVA's which may occur during the stage.

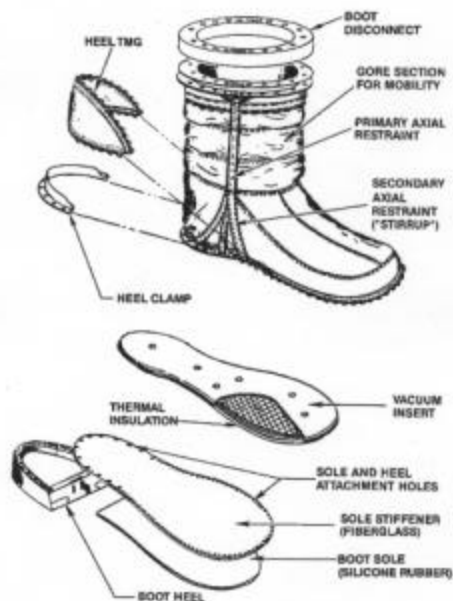
FIGURE 3.4.4 BOOT

- **EMU Boot Pressure Point**
 - Background
 - Crewmembers have experienced pressure point on feet
 - Foot discomfort has potential to be mission impact
 - Investigation Status

- Root cause is foot contact with a pressure bladder seam on the top side of the boot
 - Depending on foot size, the boot design and foot wear (multiple sock options, boot sizing insert, thermal slippers, toe caps) selected, a stack up combination can occur to provide the potential for boot fit concerns that might not be readily screened for on the ground

- To accommodate potential physiological changes on-orbit, options to increase foot easement have been provisioned (boot sizing inserts, thermal slippers, thinner socks, smooth bladder wrinkles, and leg length resizing)

- Rationale for Flight
 - Modified the boot fit check process to more effectively simulate 0-g effects
 - 7A.1 crewmen have been successfully fit checked (i.e., foot easement within boot dimensions)
